QUINQUENNIAL INSPECTION OF SUNDERLAND POINT MISSION CHURCH, MORECAMBE

DIOCESE OF BLACKBURN

1879/C-Arch/170725-QIR

Date of Inspection: 25th July 2017
Weather Conditions: Fine

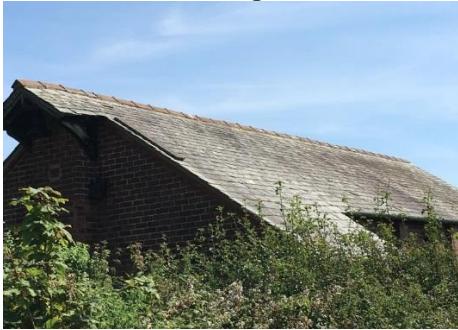
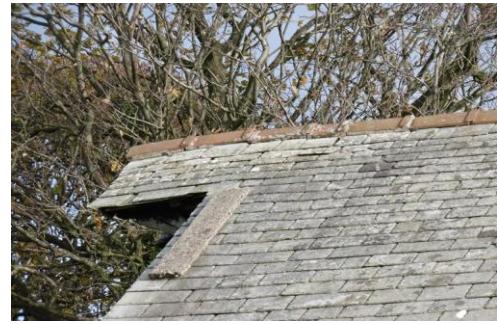
3.1.1 Roof to South facing Nave:

Condition: The slates appear to be in reasonable condition. There are no tags evident on this pitch of the roof. However, the roof seems to be sagging slightly over the canopy for the bell and there is a cast concrete plank laid over the west gable on the southern side of the pitch. The pointing on the ridge tiles looks to be reasonable, however, it is missing in a couple of places and will need to be repointed.

Repair Needs: Investigate reason for the sag on the bell canopy and minor repointing required in places.

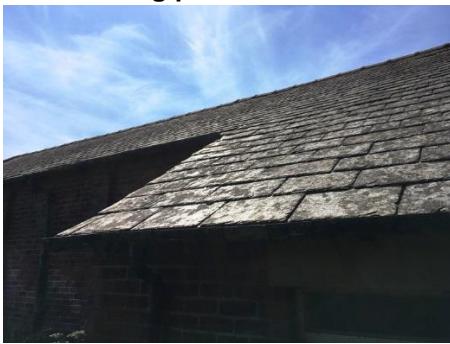
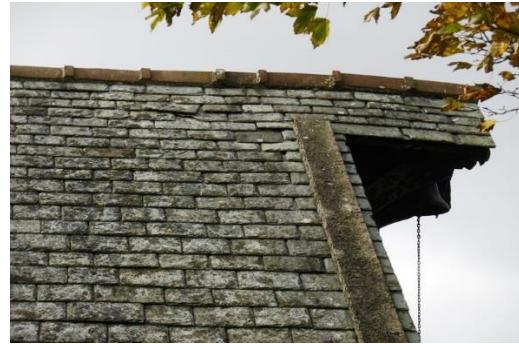
3.1.2 North Facing pitch of roof:

Condition: The roof is in fair condition, however it has a few lead tags on it (approx. 5 in number), and there is also evidence of some movement near the Bell Canopy where the roof is sagging. The concrete copings are crude and have probably been laid to protect the edges of the roof from the wind. These have split at the ends. The roof is in a reasonable order and would benefit from some constant care and attention.

Repair Needs: To investigate the cause of the sagging on the Bell Canopy, to push a few slipped slates back into place, and also to give the facia a good overhaul in and around the church (especially by the Vestry door).

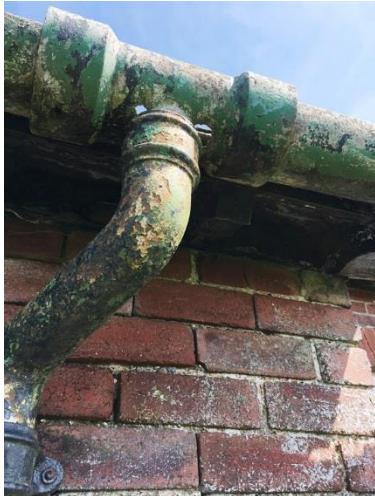
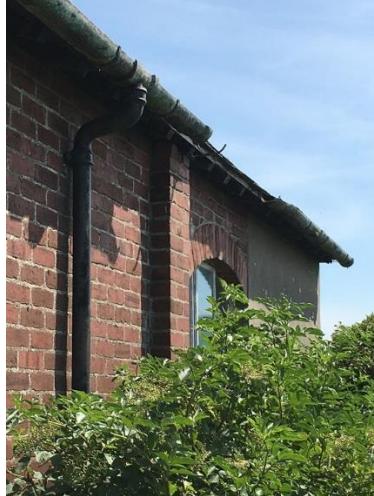
3.2.1 Rainwater Goods Generally:

Condition: On the south side of the church, the gutters are cracked in a couple of places and sections are missing. On the north side of the church the gutters and downpipes are in a reasonable condition, but could do with being redecorated. Due to the fact that the gutters are fibrous cement, and coupled with the likely age of the refurbishment of this building, the author suspects that the gutters might contain some asbestos. The church is urged, if they haven't already done so, to get an asbestos test carried out.

Repair Needs: Obtain Asbestos report (if you don't already have one), replace defective guttering on the south side of the church and repaint gutters generally.

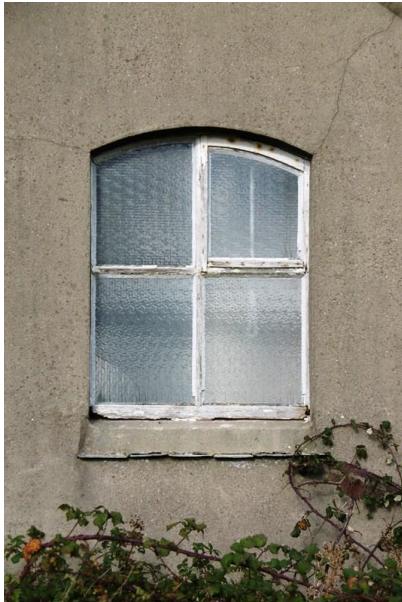
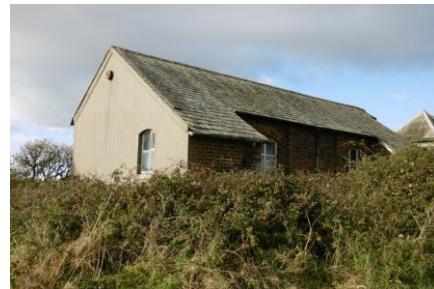
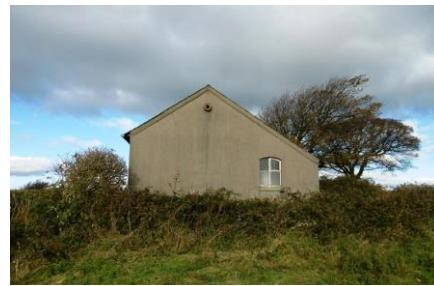
3.3.2 East Wall:

Condition: The author was unable to survey, due to the overgrown state of the land around the building. However, another Architect from HPA (Zoe Hooton) surveyed this wall in December 2016, and provided information and photographs which have been used in this report.

A non-lime roughcast coat has been applied to the entire elevation, apart from the sole window. The wall, window sill, fascia etc have been crudely covered with render. The render is beginning to crack in places (particularly to the right of the window). There are a few other problems with this wall (especially in the Vestry Area), which are reported in more details elsewhere in this report, and are likely to mean that the wall will need to be re-rendered (or another system of rain screen cladding investigated) in the future.

Repair Needs: Whilst this render will need repairing in the short term, a more holistic long term solution is needed.

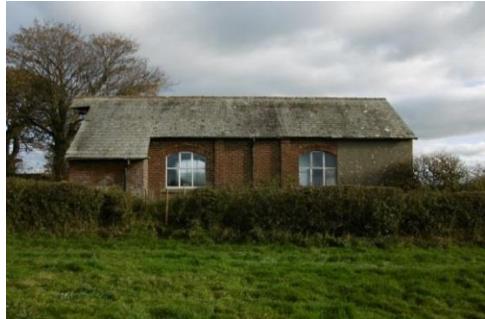
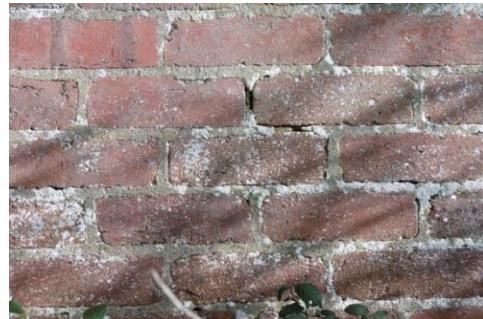
3.3.3 South Wall:

Condition: The bricks seem to be in a reasonable order, however some of the pointing is starting to disappear, particularly at the western end. The render is also cracking and showing early signs of de-bonding.

Repair Needs: Repointing as required. The render will need further investigation / monitoring, although a longer term alternative to the render may be worth considering (as per item 3.3.1).

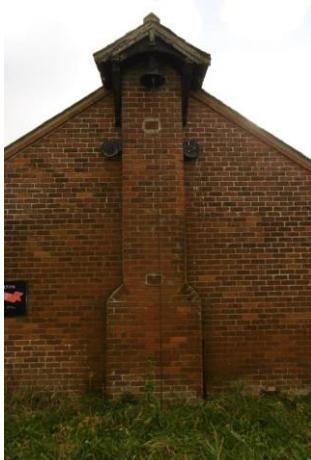
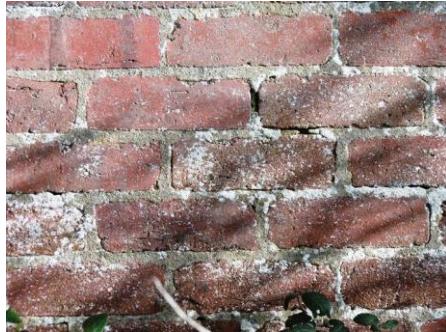
3.3.4 Western Wall:

Condition: In a moderate condition, however some of the mortar is starting to rake out, particularly on the chimney which leads up to the Bell Canopy.

Repair Needs: Repointing as required.

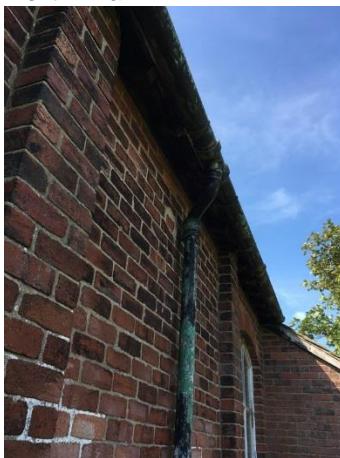
3.3.5 North Wall:

Condition: The wall is in a moderate condition with defective mortar in some areas. The cracking on the wall by the Vestry is mentioned elsewhere in the report.

Repair Needs: Rake out defective mortar and repoint as necessary using lime pointing.

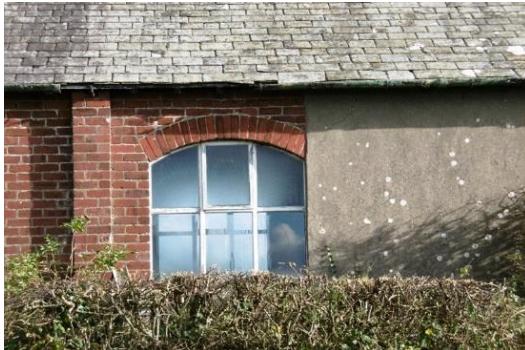
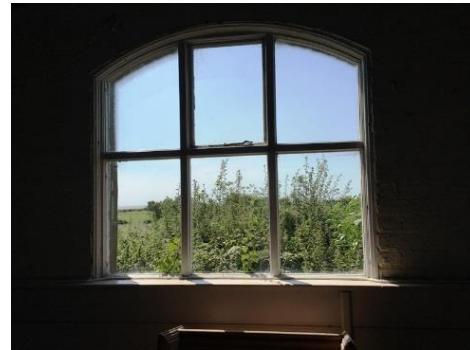
3.4.1 Window sl:

Condition: In moderate condition, some of the frame appears to be deteriorating in the top right corner and some of the putty is starting to fail. The paint is in dire need of redecoration.

Repair Needs: Check to make sure no timber is rotten, splice in new timber as required. Redecorate window, apply putty repair. It is important the church know the broken gutter lies directly above this window and it is quite likely that water has been pouring onto the window during times of rain.

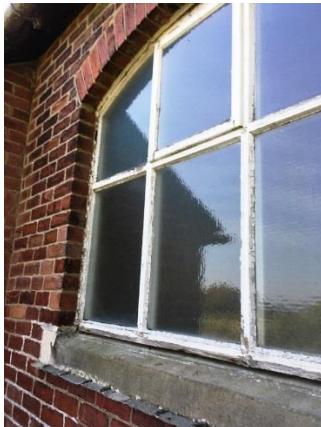
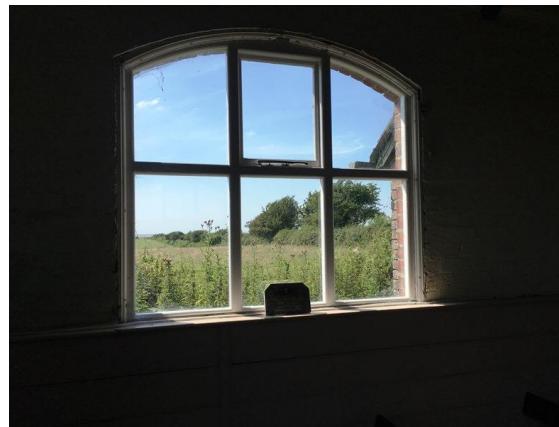
3.4.2 Window sll:

Condition: The window is in moderate condition although the putty is starting to break up and the window could do with redecoration. The bottom rail needs checking and possibly replacing.

Repair Needs: Overhaul and redecorate window.

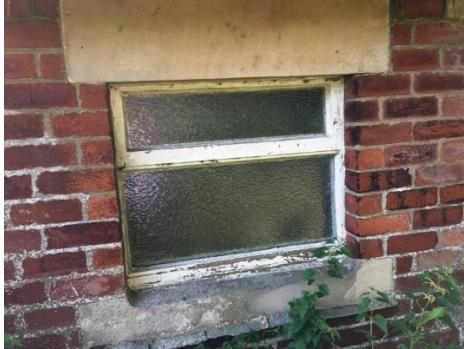
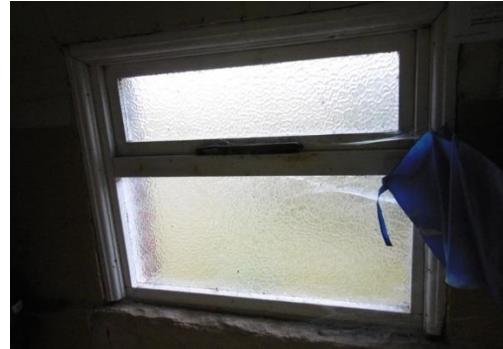
Window nIV:

Condition: The window is in poor condition. The paint work is showing the timber and needs redecorating.

Repair Needs: This window needs fettling up and repainting as a matter of urgency.

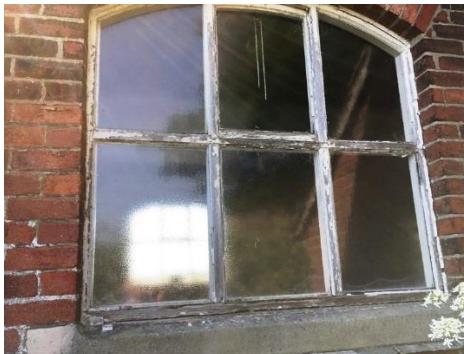
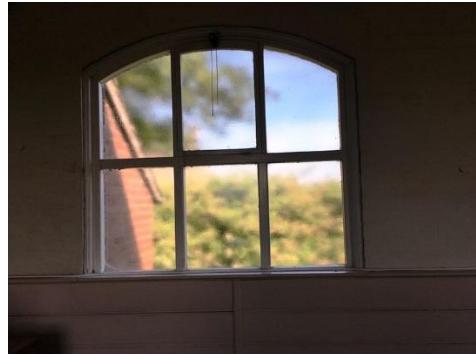
Window nIII:

Condition: The window is in bad condition and sections have deteriorated beyond repair. On balance it looks as though the window should be replaced as sections of timber have deteriorated badly.

Repair Needs: Replace window on a like for like basis. It would be advisable to use a more durable species of timber compared to that of the previous window.

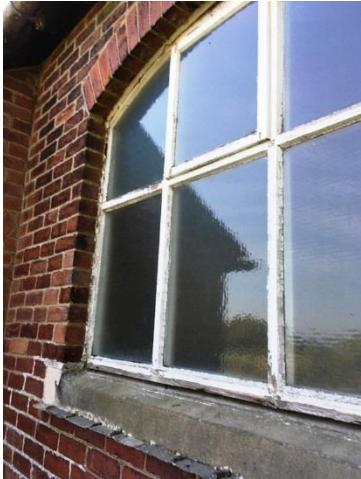
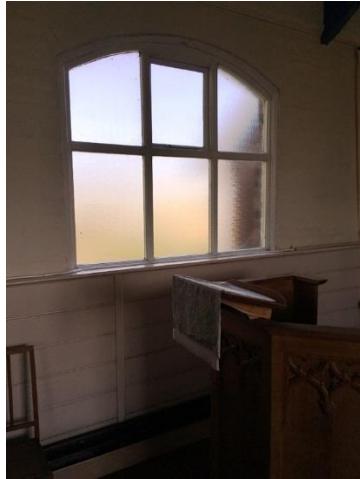
3.4.5 Window nll:

Condition: Window is in poor condition (not as bad as nIII, but is on the threshold of whether the window can be saved or a new window is required). Suggest a joiner is asked to have a look at the window and comment accordingly.

Repair Needs: Carry out urgent repairs and redecoration to window, or replace window on a like for like basis. If replacing the window, it would be advisable to a more durable species of timber than the previous frame.

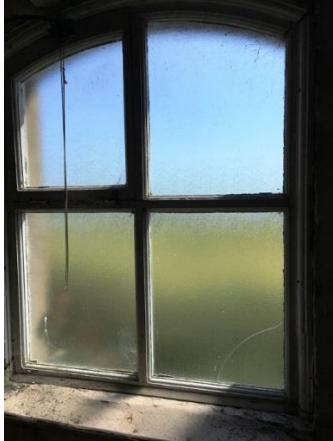
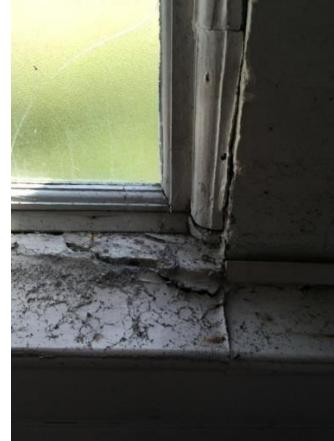
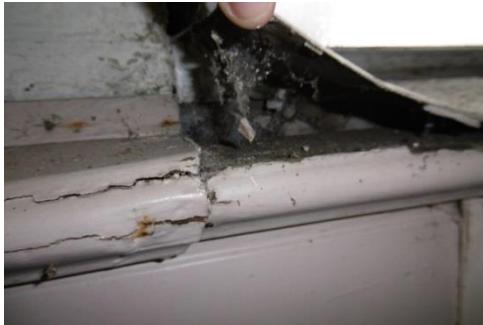
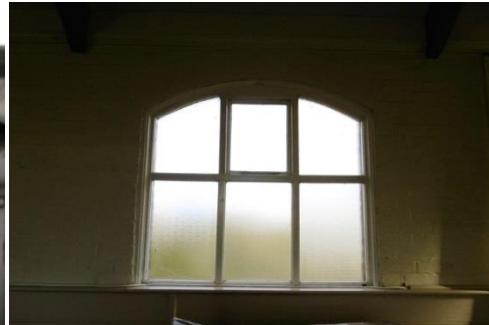
3.4.6 Window n1:

Condition: The window is in poor order and is rotten in places. There is a crack in the bottom section of glass. The sill is lifting and it appears that externally the sill has completely failed.

Repair Needs: The window needs replacing. Please note that there are multiple problems with this wall. Just replacing this window, and doing nothing else to the wall will not provide a long term solution, and the same problem will only happen again! A

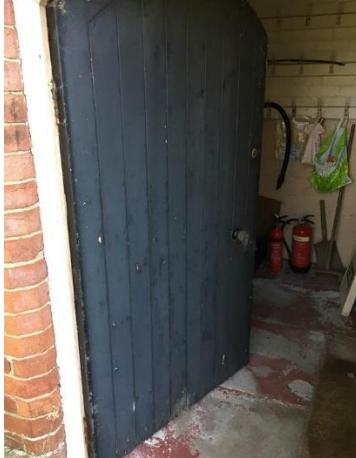
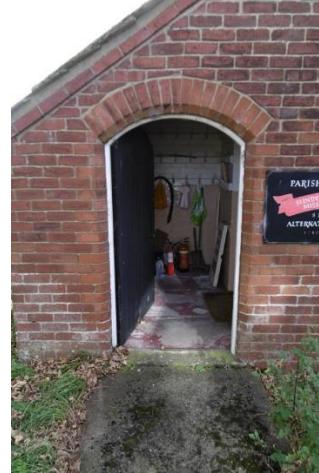
Main Door to Church:

Condition: The door is in reasonable condition. There is evidence of some deterioration at the base of the door, and the base of the surround on the left hand side.

Repair Needs: Remove defective timber and splice in a new panel at the base of the door. Repair left hand side of the base of surround. Redecorate door as a matter of urgency.

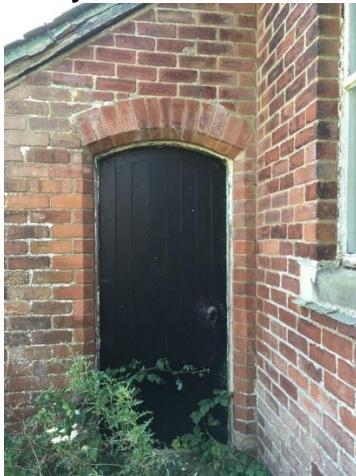
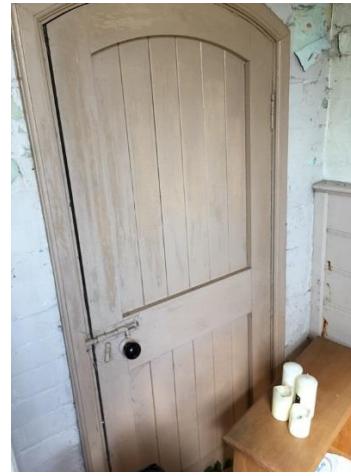
Vestry Door:

Condition: The door is in moderate condition, and requires urgent redecoration. The door surround is showing bare wood, although it is not yet rotten. There are brambles growing under the door and entering the building.

Repair Needs: Redecorate the door and remove brambles as a matter of urgency

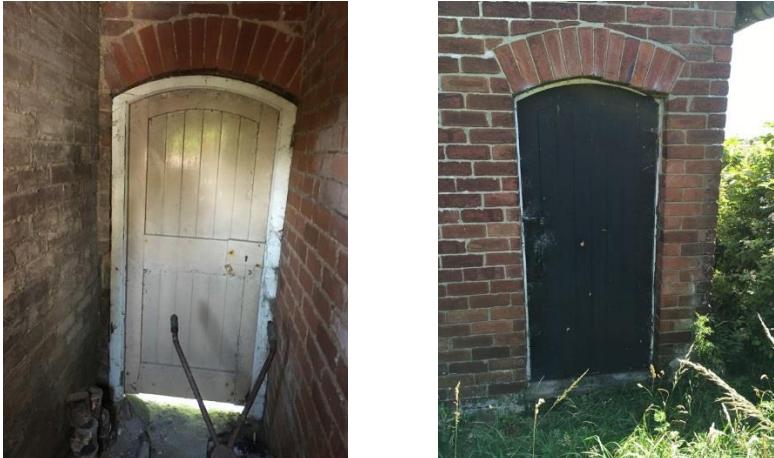
3.5.3 Door to External Store:

Condition: The door appears to be in a moderate condition, and could do with being redecorated. The surround also needs redecorating, and elements of the surround need pointing into the brick work properly. The door has been sealed shut and cannot be opened without a crowbar!

Repair Needs: Remedy various problems with the door and redecorate as a matter of urgency

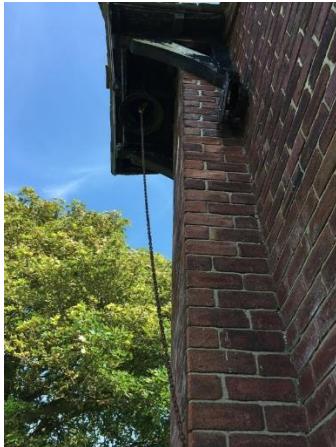
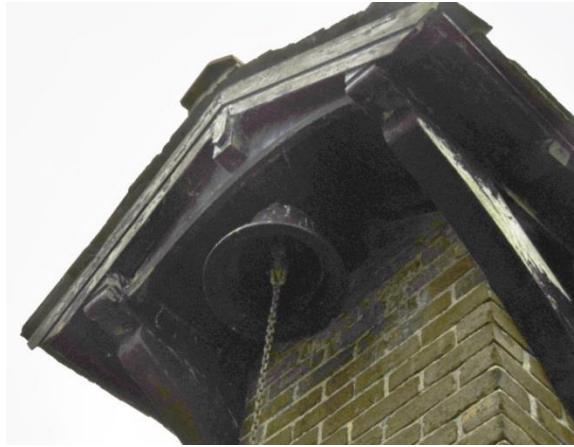
3.7**Bells:**

Condition: The bell appears to be in good order, however the canopy is leaning, possibly due to timber deterioration on the ridge and gallows brackets. This appears to be historic and is reported to have been like this for many years. One slate has slipped in the bottom corner on the south pitch of the canopy for the bell. This needs to be put back into place.

Repair Needs: Inspect the stability of the canopy, redecorate the canopy, and monitor for further movement. Reset slate on south pitch of canopy and repoint ridge tiles in this area to prevent water ingress.

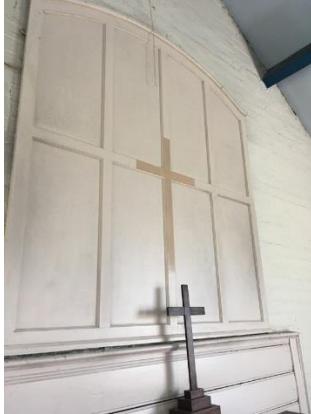
4.4.1 East Wall Internally:

Condition: In moderate condition. There is evidence of some cracking especially down from the purlin on the south pitch of the roof. There is also evidence of slight separation (3-5mm) between the wall and the ceiling panel, which is probably due to normal natural shrinkage. There also is an opening ventilation panel at high level on the east end which appears to be stuck open. During the inspection, a wood pigeon could be heard within the vent, and the author suspects something is nesting within the ventilation area. The area around the wainscoting by window nl also needs to be replaced.

Repair Needs: Repair to cracks and redecoration of the wall would be advisable. Remove nest from air vent at appropriate time of year.

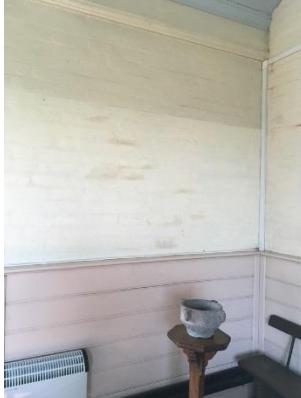
4.4.2 South Wall to Nave and Chancel:

Condition: Brick work appears to be showing signs of paint being blown off due to moisture ingress. The wall appeared to be dry at the time of inspection however, the paint is flaking.

Repair Needs: The wall could do with being stripped and being redecorated using a breathable mineral paint.

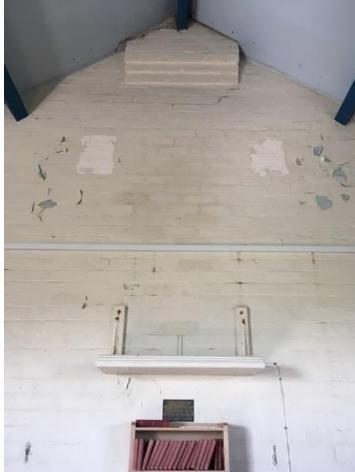
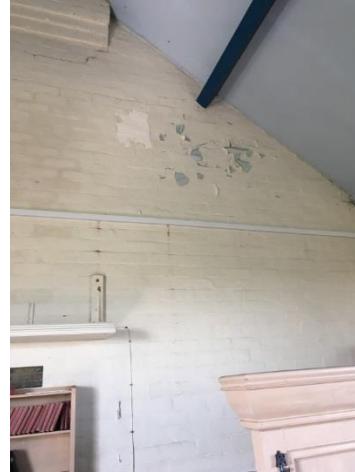
4.4.3 West Wall of Nave:

Condition: In moderate condition. The wainscoting appears to be in reasonable order, however there is evidence of paint flaking off the brick work at high level. There is also evidence of damp ingress on the line of the old chimney at high level, and also evidence of some cracking in the upper courses of the brick work.

The cracking and damp are possibly linked to the issues relating to the fact that the bell canopy is leaning. The crack is due to the structural settlement, and the damp is likely to be caused by water ingress entering from the gaps in the slates and ridge tiles.

Repair Needs: Address the problems with the bell canopy and roof, before making good this wall. Redecorate with breathable mineral paint. D

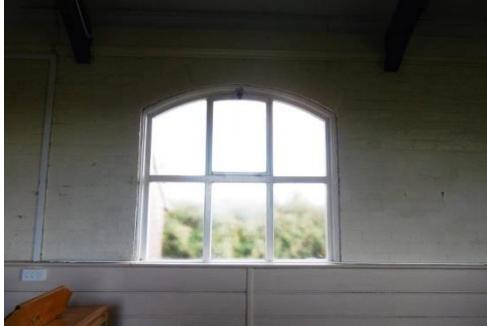
4.4.4 North wall of Nave:

Condition: As with other walls, paint work is beginning to flake away, probably due to an accumulation of issues (pointing issues, defective rainwater goods, the use of non breathable egg shell etc).

Repair Needs: Address external issues, before stripping back to brickwork and repaint with a breathable mineral paint. D

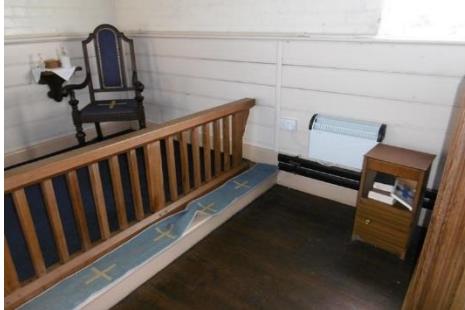
4.5.1 Floor to Chancel:

Condition: The carpet is in reasonable order, however, part of the platform floor appears to be leaning in an easterly direction towards the Vestry.

Repair Needs: The settlement is likely to be linked to the cracking on the walls in the Vestry, and needs to be inspected by a Structural Engineer.

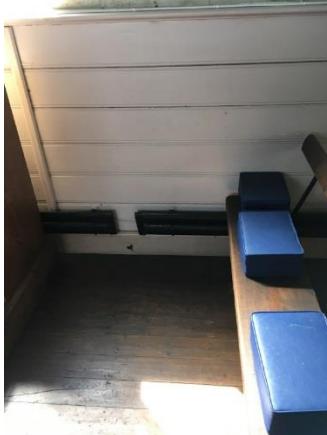
4.5.2 Floor to Nave generally:

Condition: The floor is in a reasonable condition. The carpet is in reasonable order too. However, there is a soft spot on the floor immediately to the west of the internal door between the Nave and the Porch. This suggests that there is settlement, or deterioration of the floor joists in this area.

Repair Needs: Intrusive inspection of the structure to the floor is needed by Door 4, between the Nave and the Porch.

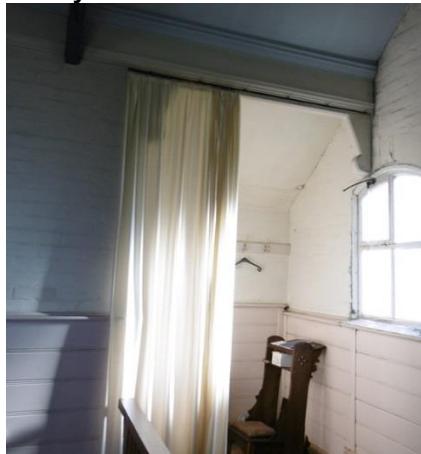
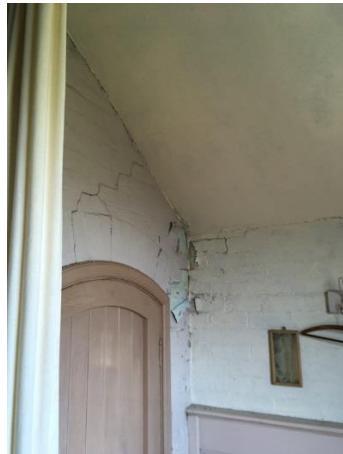
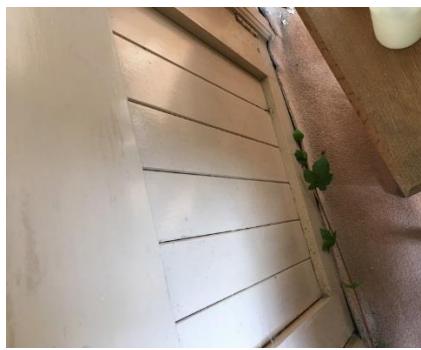
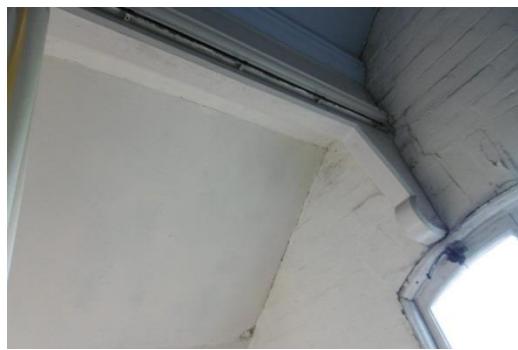
4.7.1 Vestry:

Condition: The corner of the building appears to have dropped historically and needs to be investigated. The wainscoting has dropped approx. 3 inches, and the floor in the corner of the Vestry appears to have also dropped. There is evidence of plant growth coming in under the door.

Repair Needs: Identify the reason why the floor has dropped in this area (defective rafters?) Implement repairs. The Vestry also could be redecorated using a breathable mineral paint.

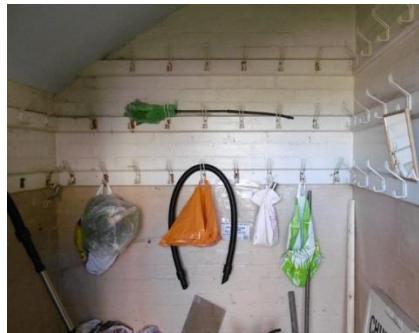
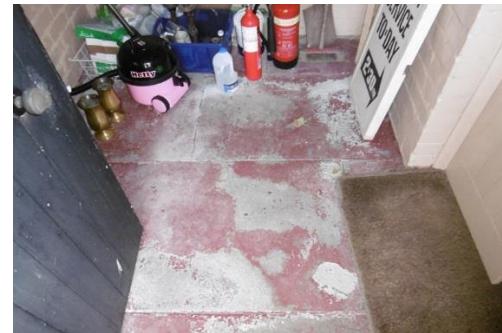
4.7.2 Internal Entrance Area:

Condition: The brick work is starting to blister and needs redecorating. The flagged floor also. The space is suffering from condensation.

Repair Needs: Redecorate and clean up, increase ventilation.

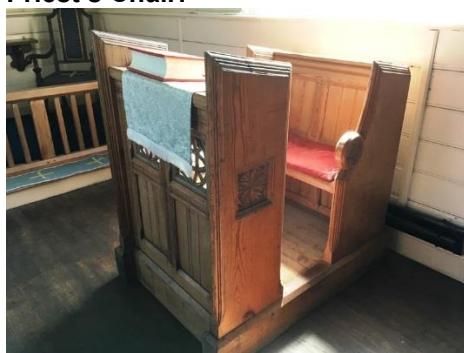
4.8.3 Priest's Chair:

Condition: In moderate condition, although could do with a good clean and some oil to the timber work to stop it drying out (as the chair sits in full sun).

Repair Needs: Danish Oil to be applied to the chair.

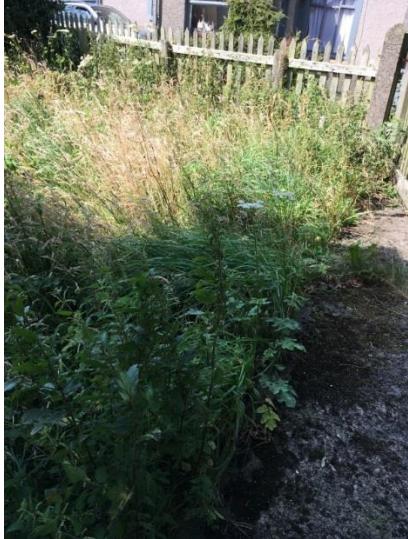
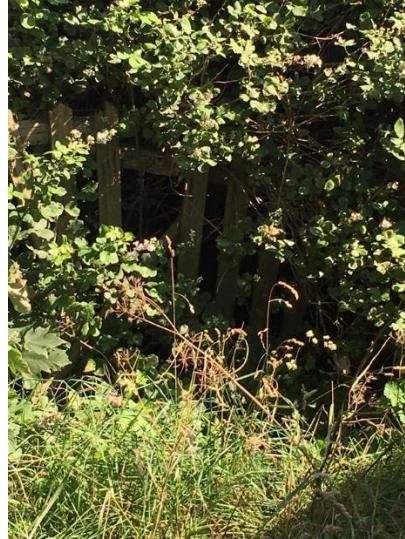
5.1 Churchyard Generally:

Condition: The churchyard is overgrown and is in desperate need of some trimming back. B

Repair Needs: Urgent gardening required!

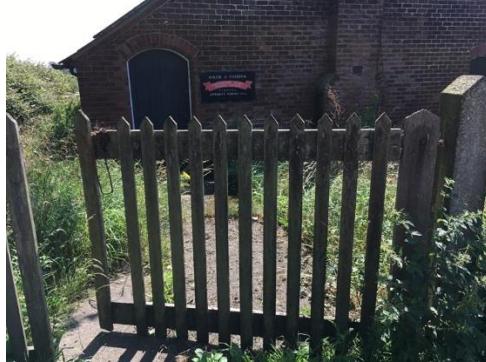
5.4 Entrance Gates:

Condition: These are in a moderate to poor condition and could do with being either fettled up or replaced.

Repair Needs: General repairs to gates or replace with new.

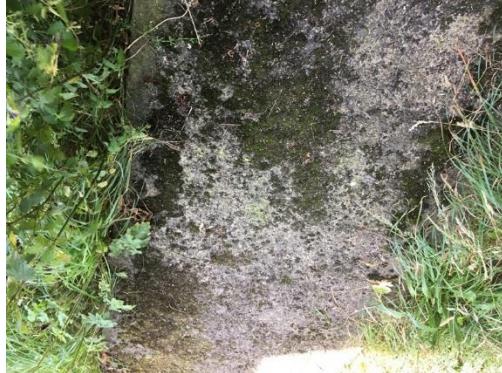
5.5 Paths:

Condition: This path is in a moderate condition, and is fit for purpose at the moment but will need replacing at some stage in the future.
