QUINQUENNIAL INSPECTION OF SUNDERLAND POINT MISSION CHURCH, MORECAMBE

DIOCESE OF BLACKBURN

1879/C-Arch/170725-QIR

Date of Inspection: 25th July 2017
Weather Conditions: Fine

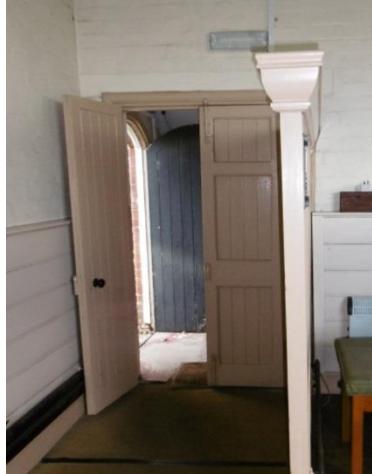
4.6.1 Door between Lobby and Nave:

Condition: In reasonable order.

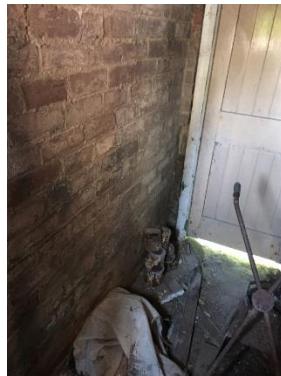
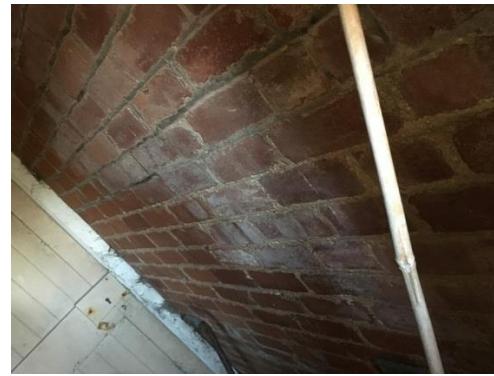
4.7.3 Store:

Condition: Simple externally accessed store, with large ventilation slots. The space was designed to be semi-external in nature, and is used appropriately.

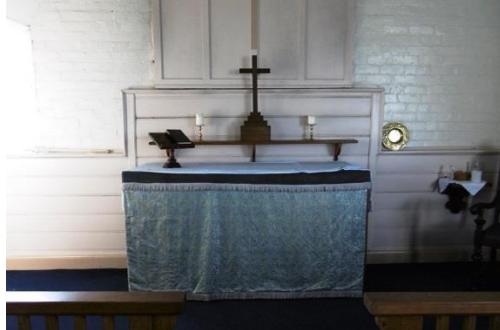
4.8.1 Altar:

Condition: In moderate condition.

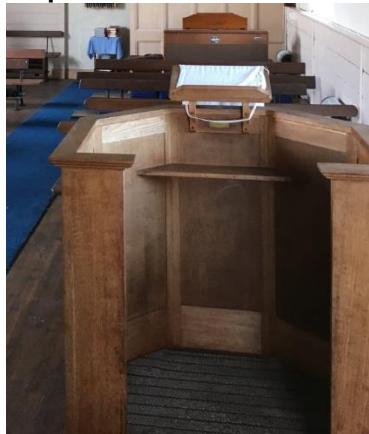
4.8.2 Pulpit:

Condition: Fit for purpose.

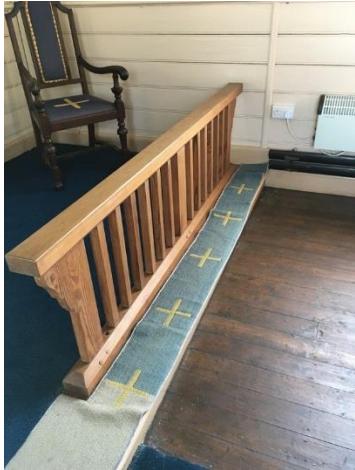
4.8.4 Altar Rail:

Condition: In reasonable order.

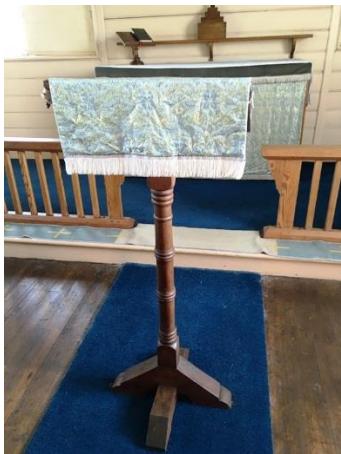
4.8.5 Lectern:

Condition: In reasonable order.

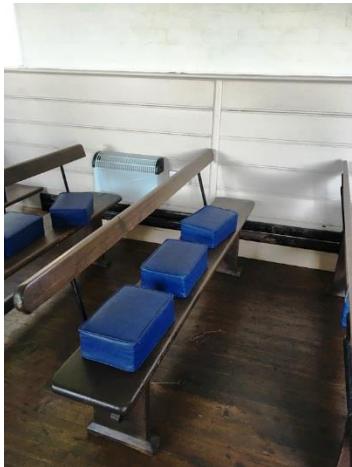
4.8.6 Pews:

Condition: In reasonable condition.

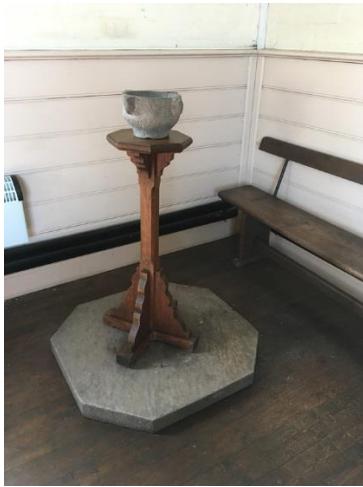
4.8.7 Font:

Condition: In reasonable condition.

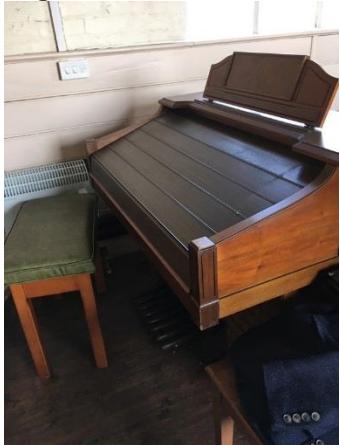
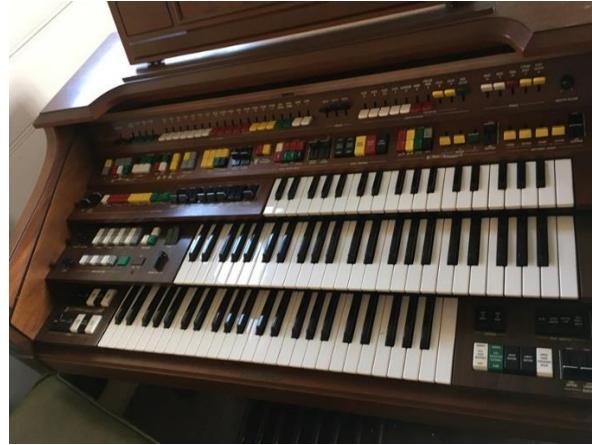
4.8.8 Organ:

Condition: In reasonable condition.

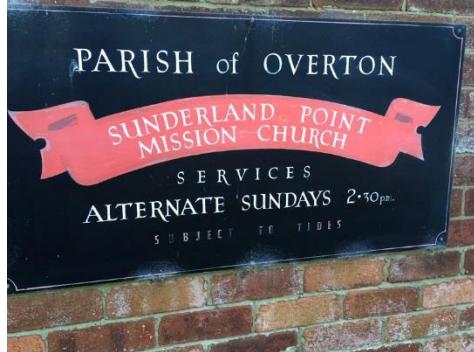
5.7 Notice Board:

Condition: In good order.

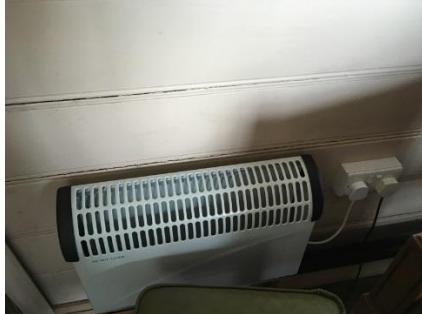
6.1 Heating:

Condition: The panel heaters are modern and obviously fit for purpose. However, they look incredibly inefficient.

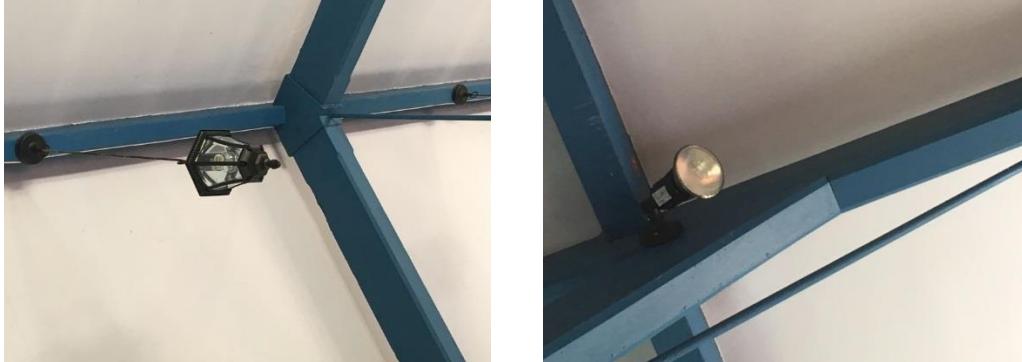
6.2.2 Lighting:

Condition: Modern fittings in good order. The church could consider using low energy LED bulbs

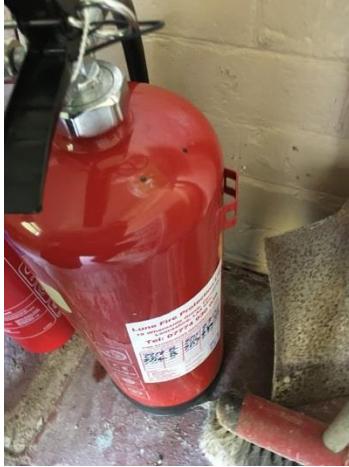
6.5.1 Fire Protection generally:

Condition: The fire extinguishers show evidence that they have been recently inspected.
